ON-SITE AIR BAG INVESTIGATION

CASE NO. - 94-18
FLEET - PRIVATE VEHICLE
LOCATION - [REDACTED] NEBRASKA
ACCIDENT DATE - [REDACTED] 1994

This report concerns a motor vehicle crash involving an air bag equipped 1992 Ford Taurus LX, four-door sedan occurring on [REDACTED] 1994 at 11:40 a.m., near [REDACTED] Nebraska on a county road. This crash is of special interest because it was alleged that the driver-side air bag had caused severe head injuries to the driver of the case vehicle.

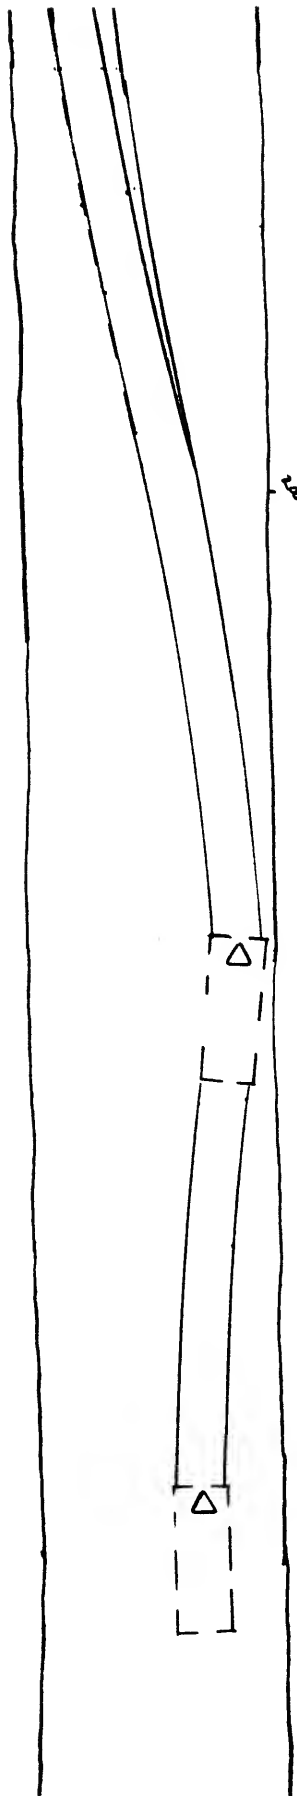
Case vehicle swerves
toward the right and
then back toward
the left. Case vehicle
begins to rotate
clockwise.

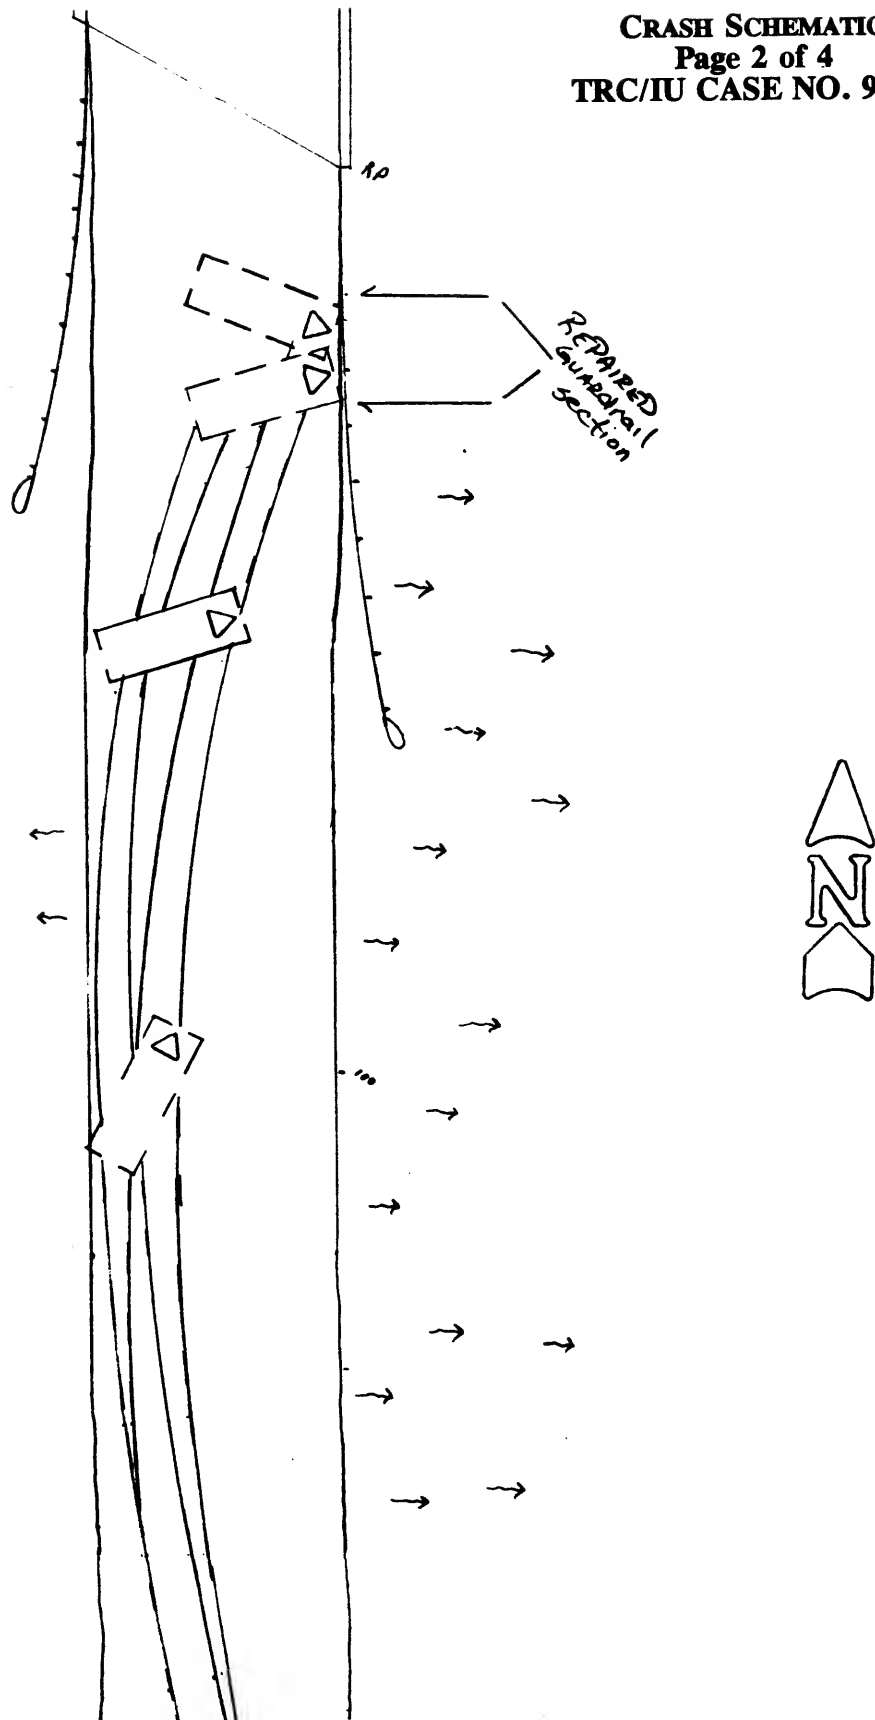
Case vehicle continues
to rotate clockwise
and impacts a guard-
rail located on the
east roadside which
protects the approach
to a bridge.

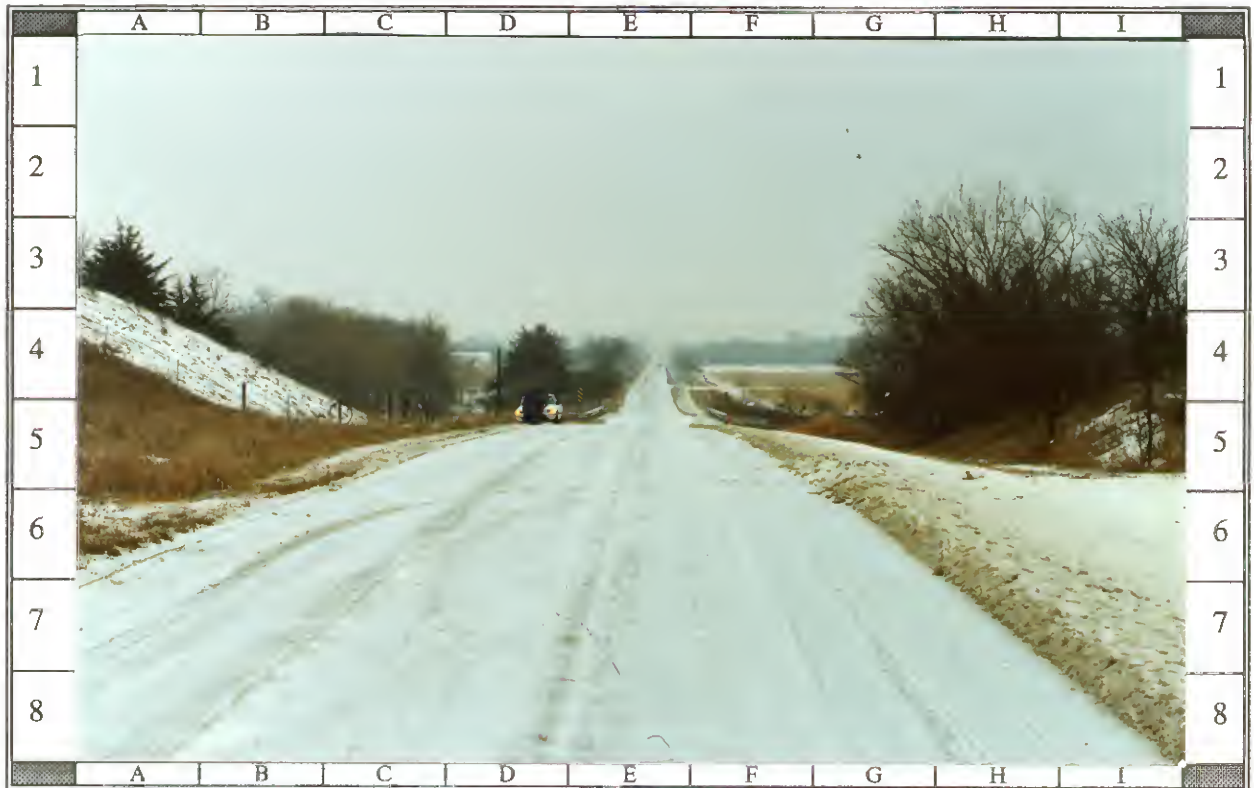
01 -- 1992 Ford Taurus's northward approach on gravel road toward bridge--approximately 100 meters south of guardrail impact

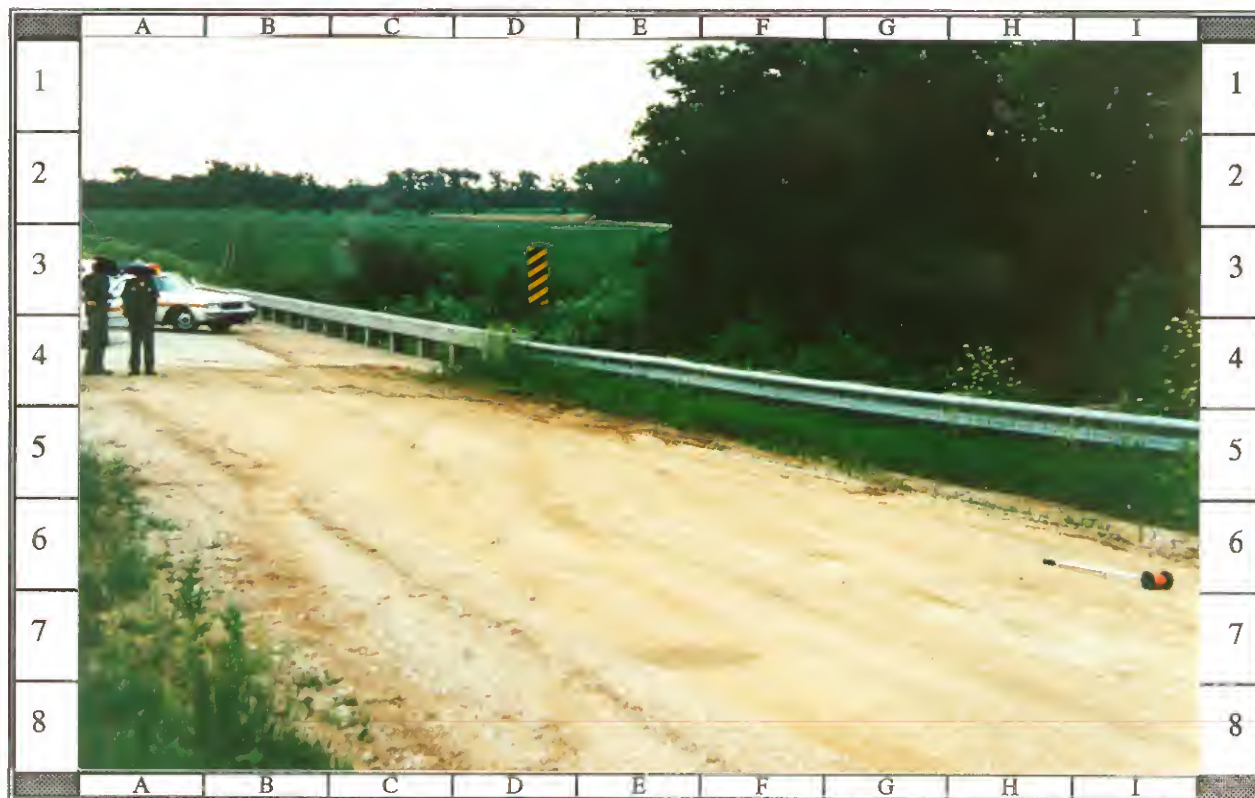
02 -- 1992 Ford Taurus's northward approach toward bridge at ~ beginning of clockwise rotation; NOTE: guardrail impact in cell G6

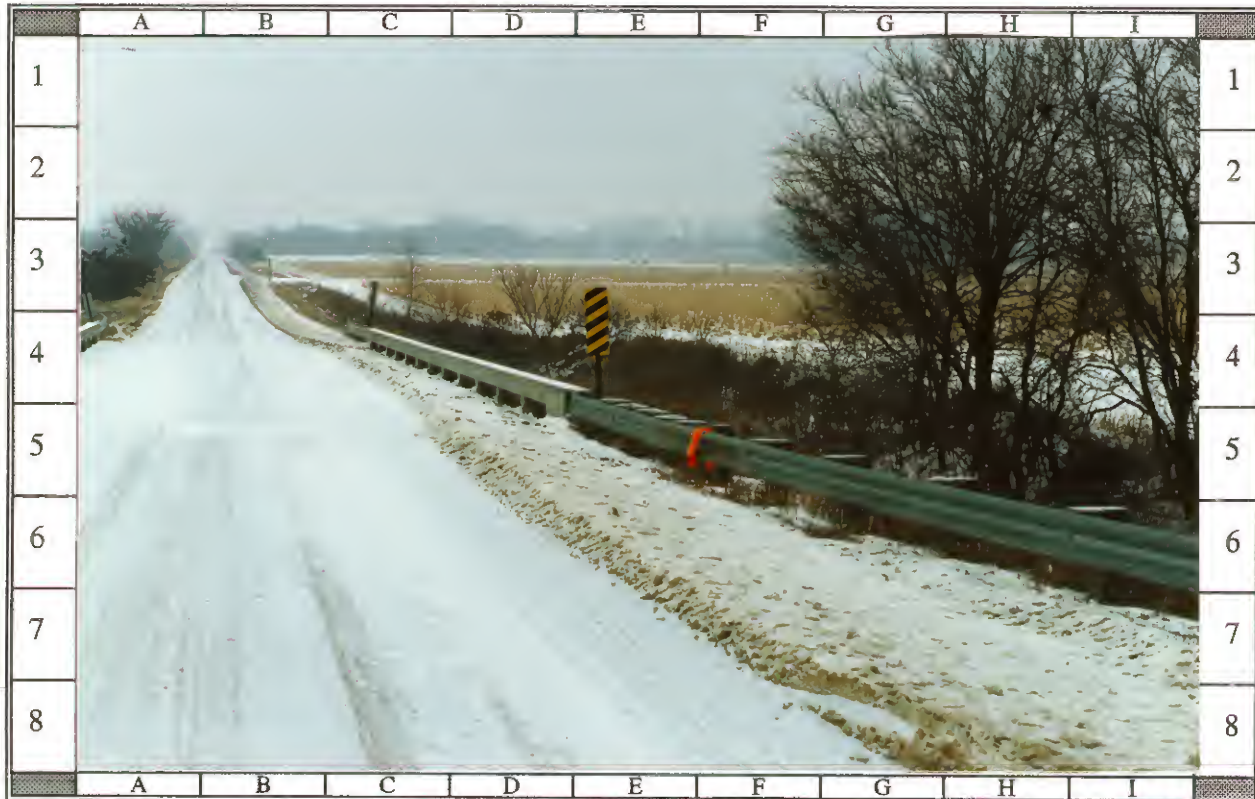
03 -- On scene view, looking NE, of 1992 Ford Taurus's guardrail impact--see cell E4; NOTE: four-tire clockwise rotation scuffs

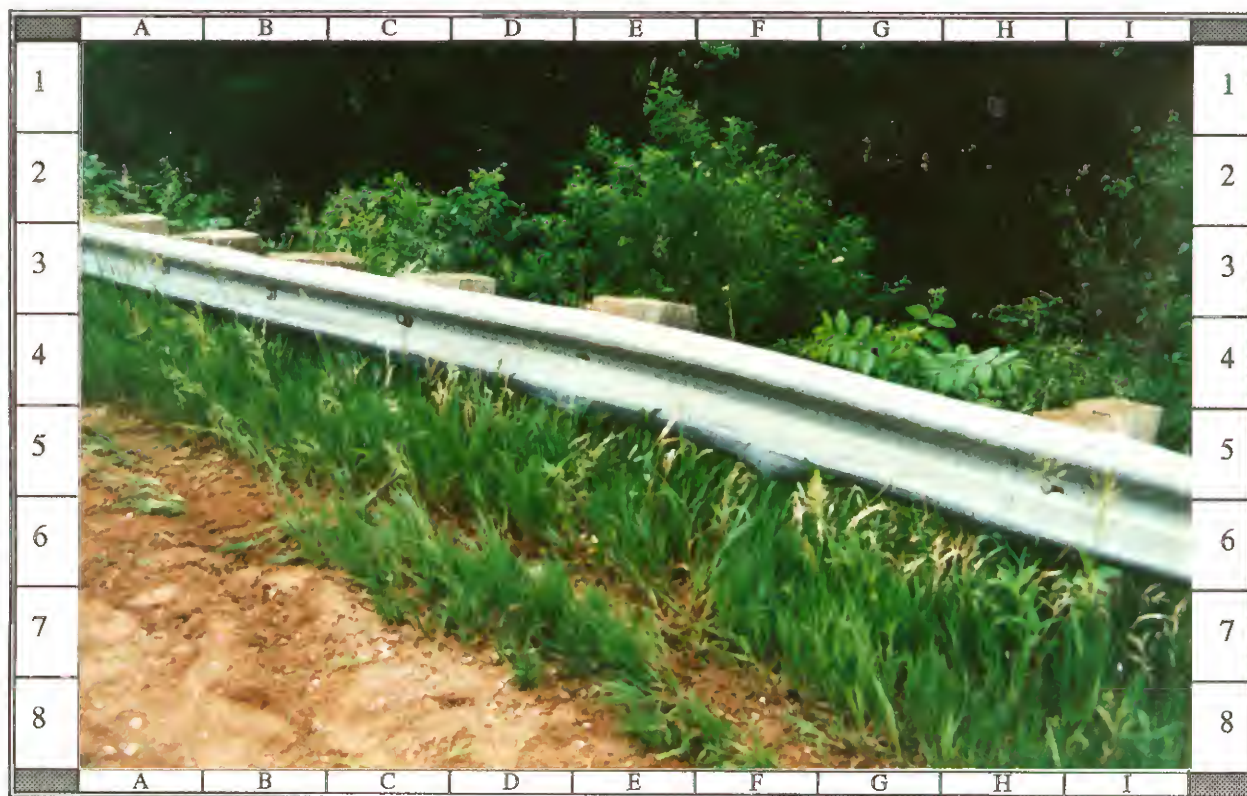
04 -- North-northeast view of 1992 Ford Taurus's guardrail impact--see red flag in cells E5--F5; NOTE: guardrail repaired no evidence

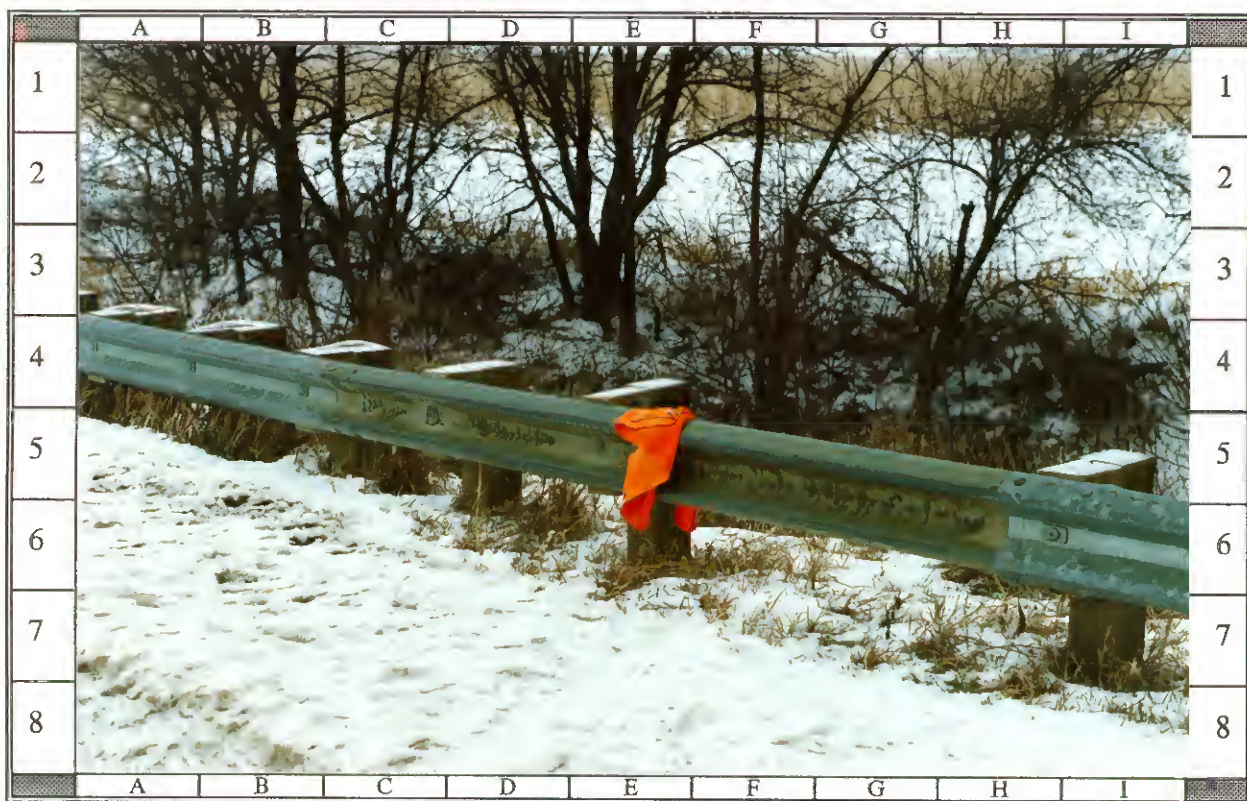
05 -- Close-up on scene view, looking NE, of 1992 Ford Taurus's impact with guardrail (cells D4--F5); see RF tire mark near rail

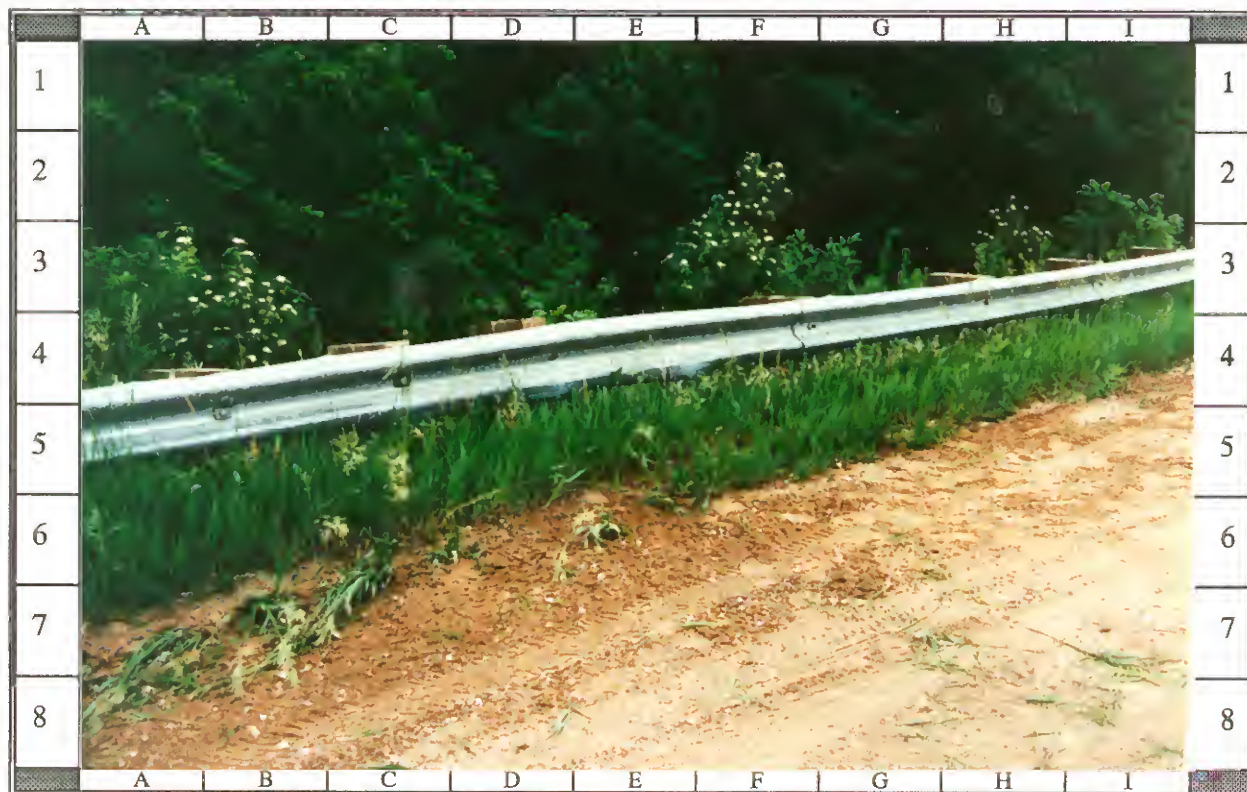
06 -- NE view of replacement guardrail impacted by 1992 Ford Taurus;
NOTE: in Photo #05 above guardrail was ripped from holding pin

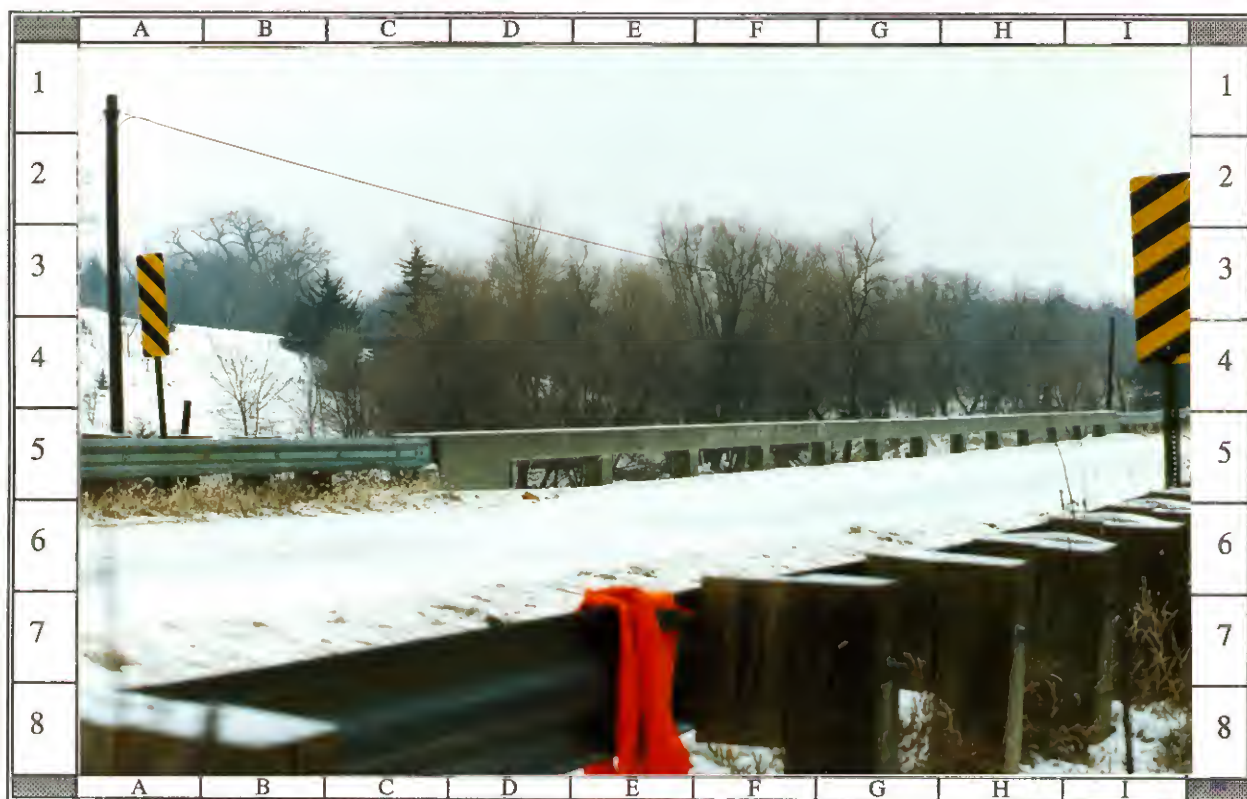
07 -- On scene view, looking SE, of 1992 Ford Taurus's guardrail impact--see cells D4--F4; NOTE: hole from holding pin in cell D4

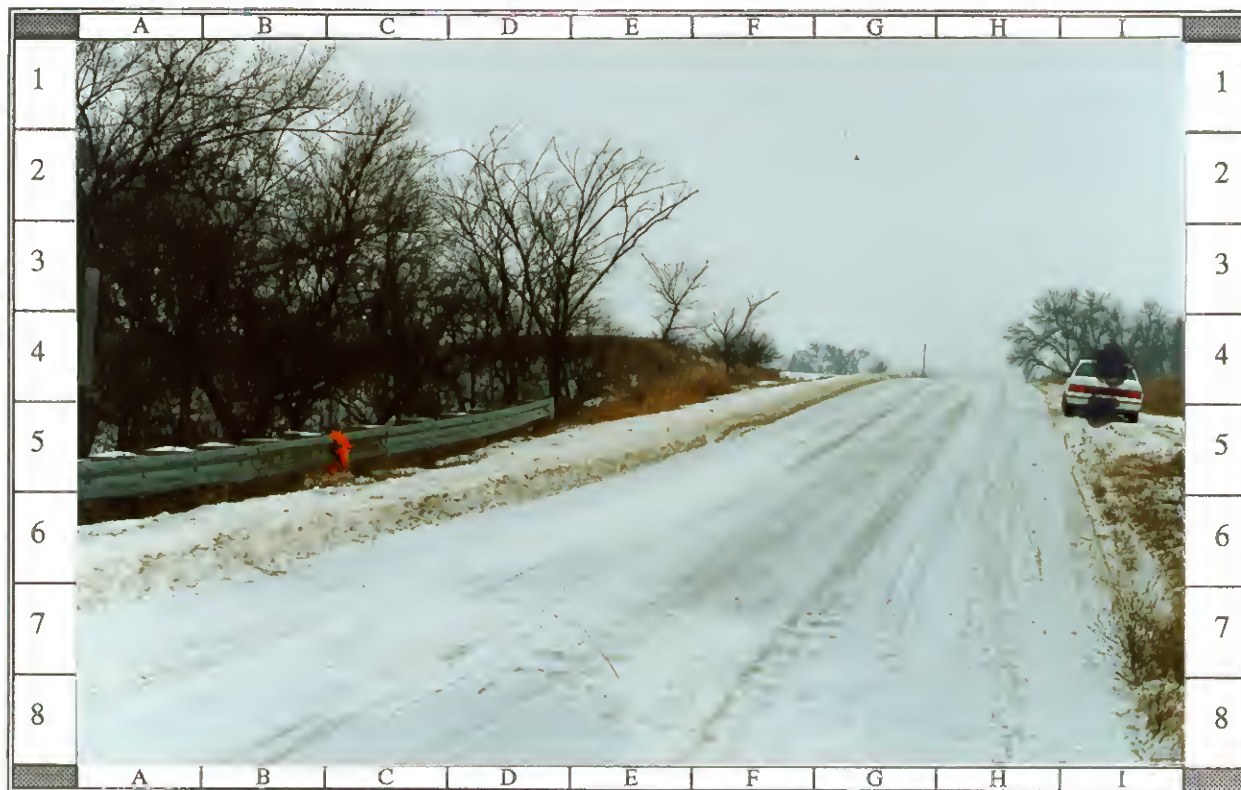
08 -- Northwest view of 1992 Ford Taurus's post-guardrail impact direction of travel onto bridge from behind replacement guardrail

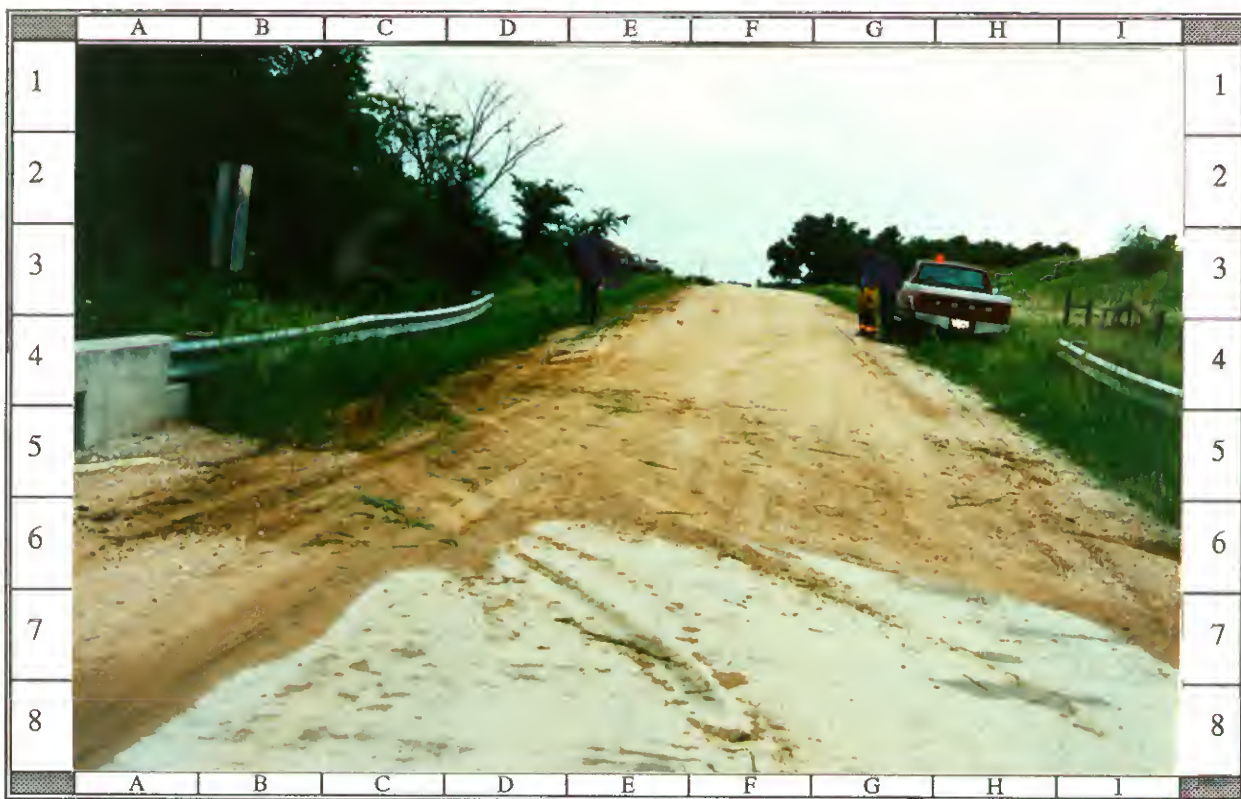
10 -- On scene view, looking south, of '92 Ford Taurus's post-guard-rail impact CW travel to initial rest area; NOTE: tire marks

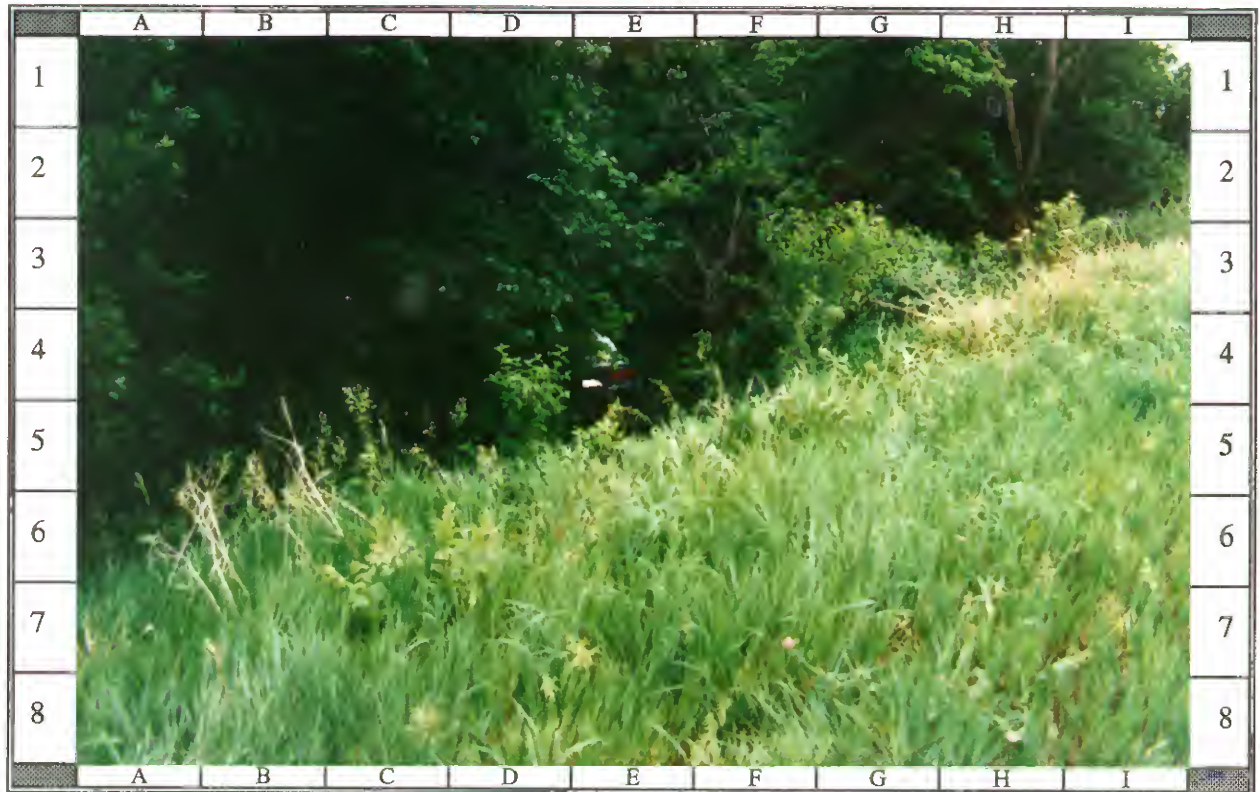
13 -- On scene view, looking E-SE from east roadside, of 1992 Ford Taurus's final rest position at bottom of embankment

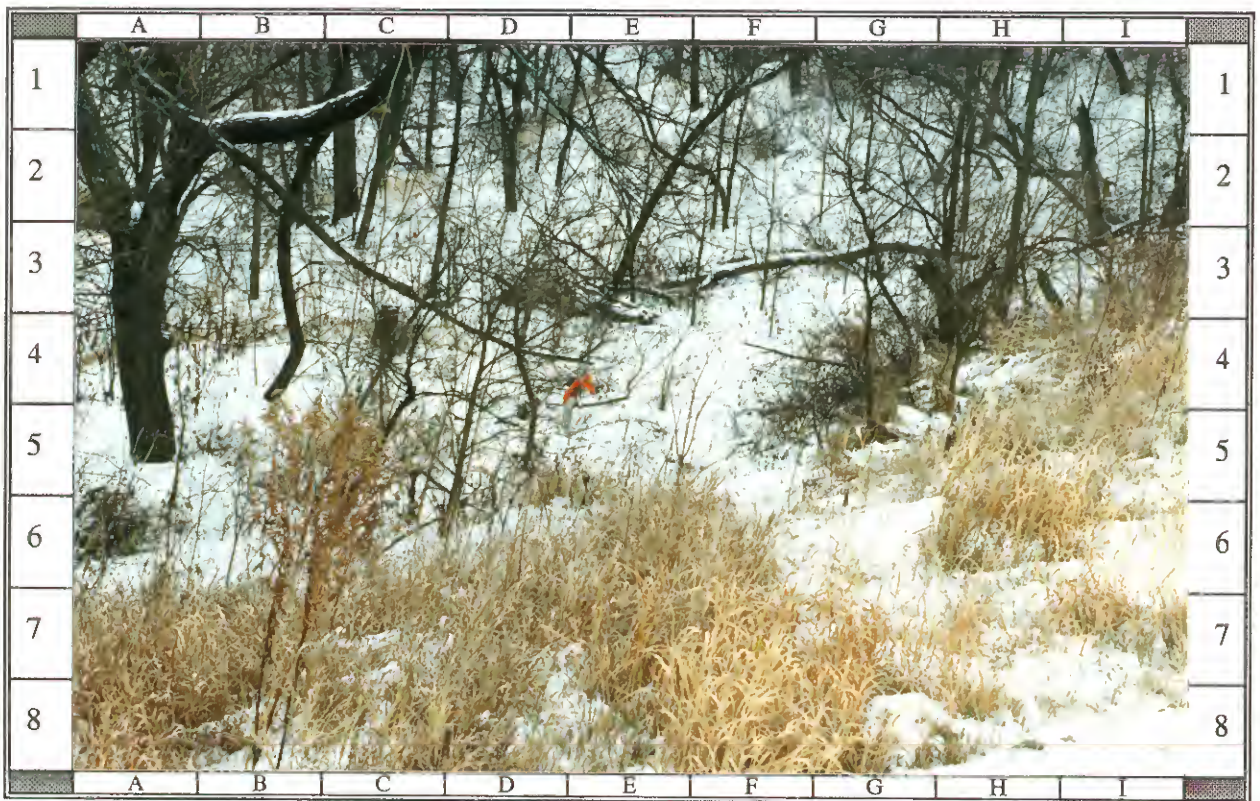
14 -- East-southeast view from E roadside of '92 Ford Taurus's ~ final rest position (red flag) at bottom of embankment--see cell E4

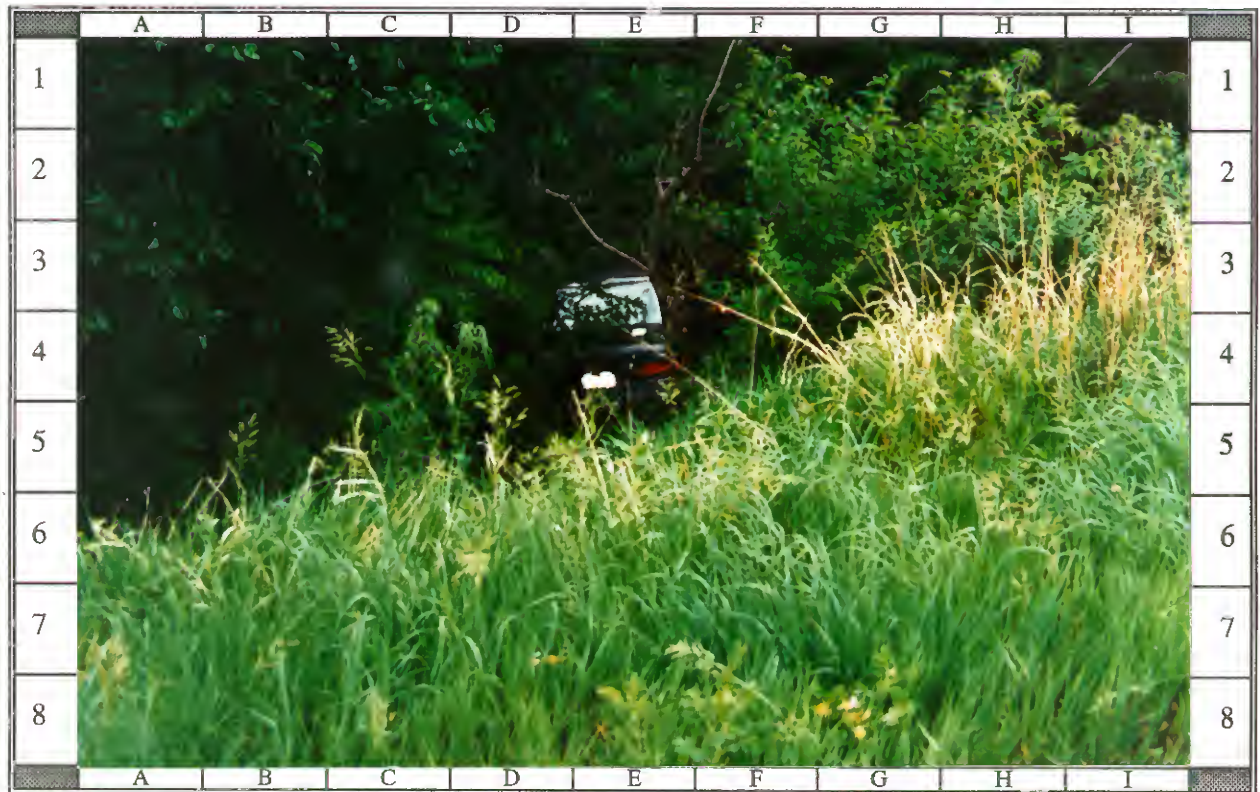
15 -- On scene view, looking E-SE from mid-point of E embankment, of 1992 Ford Taurus's final rest position at bottom of embankment

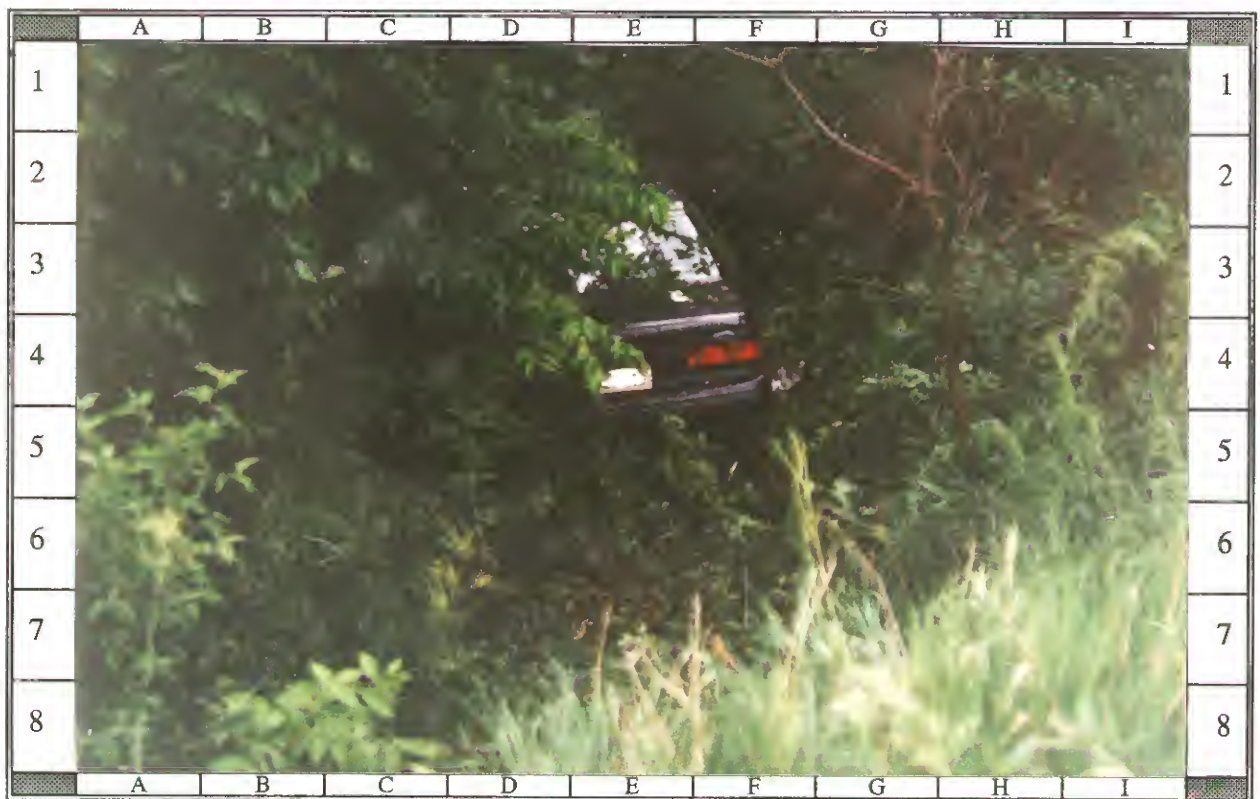
16 -- Close-up on scene view, looking E-SE, of '92 Ford Taurus's FRP at bottom of embankment; NOTE: tree & limbs (see cells F1--H5)

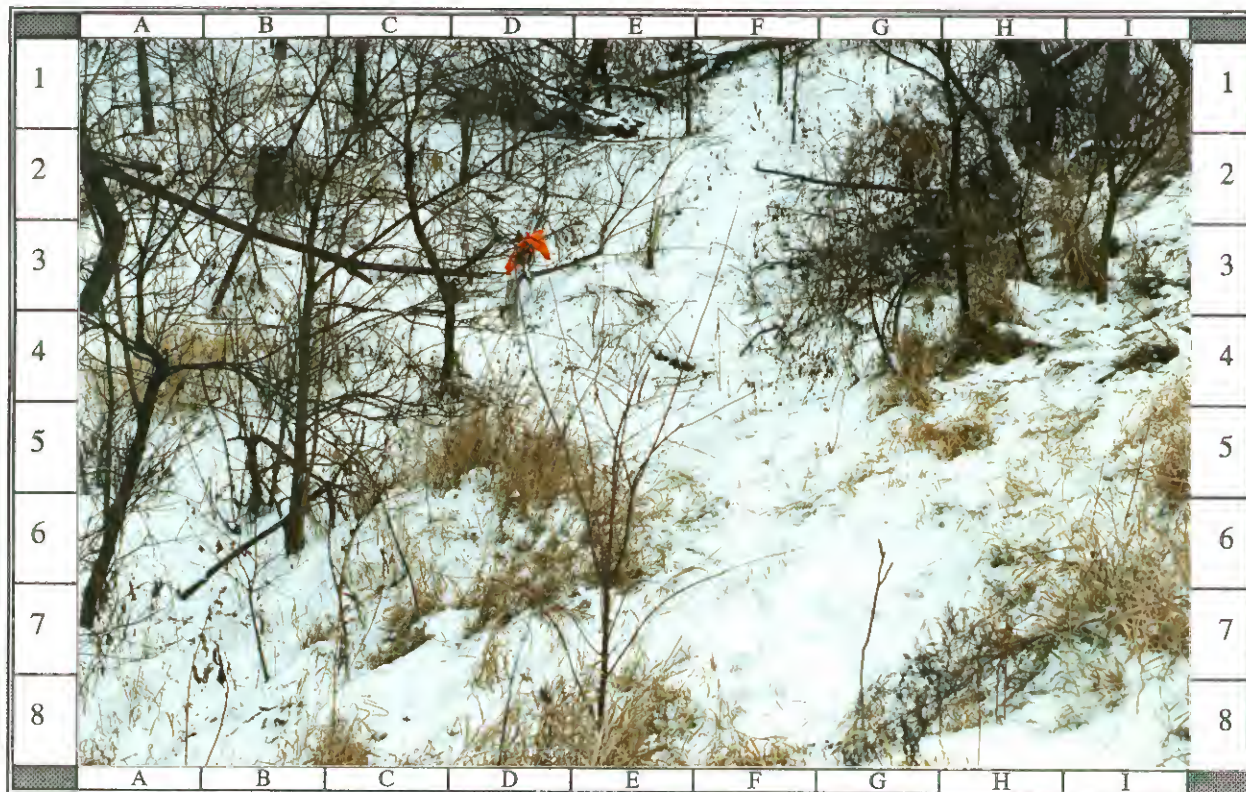
17 -- E-SE view from midpoint of E embankment of 1992 Ford Taurus's ~ FRP at bottom; compare tree & limbs (cells G1--H4) in photo #16

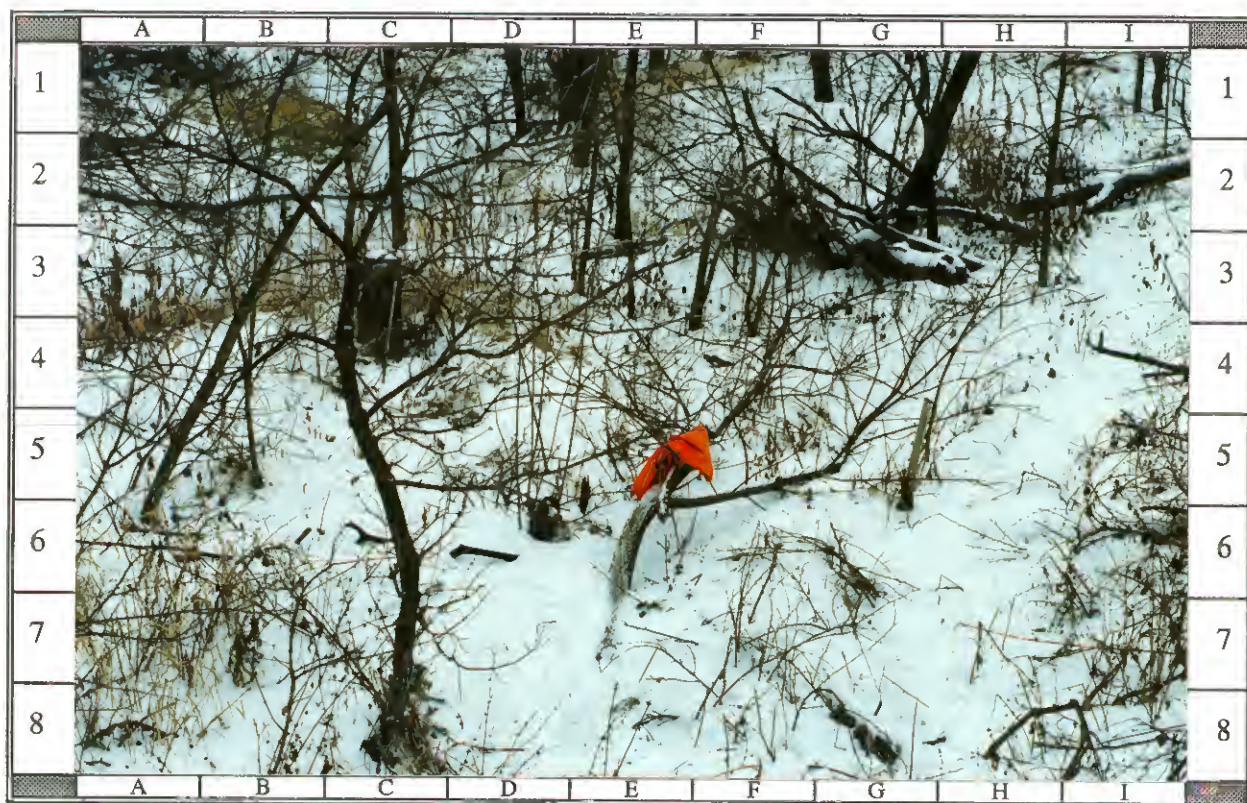
18 -- Close-up of 1992 Ford Taurus's ~ FRP at embankment bottom heading E-SE; cell G8 shows embankment impact that deployed air bag

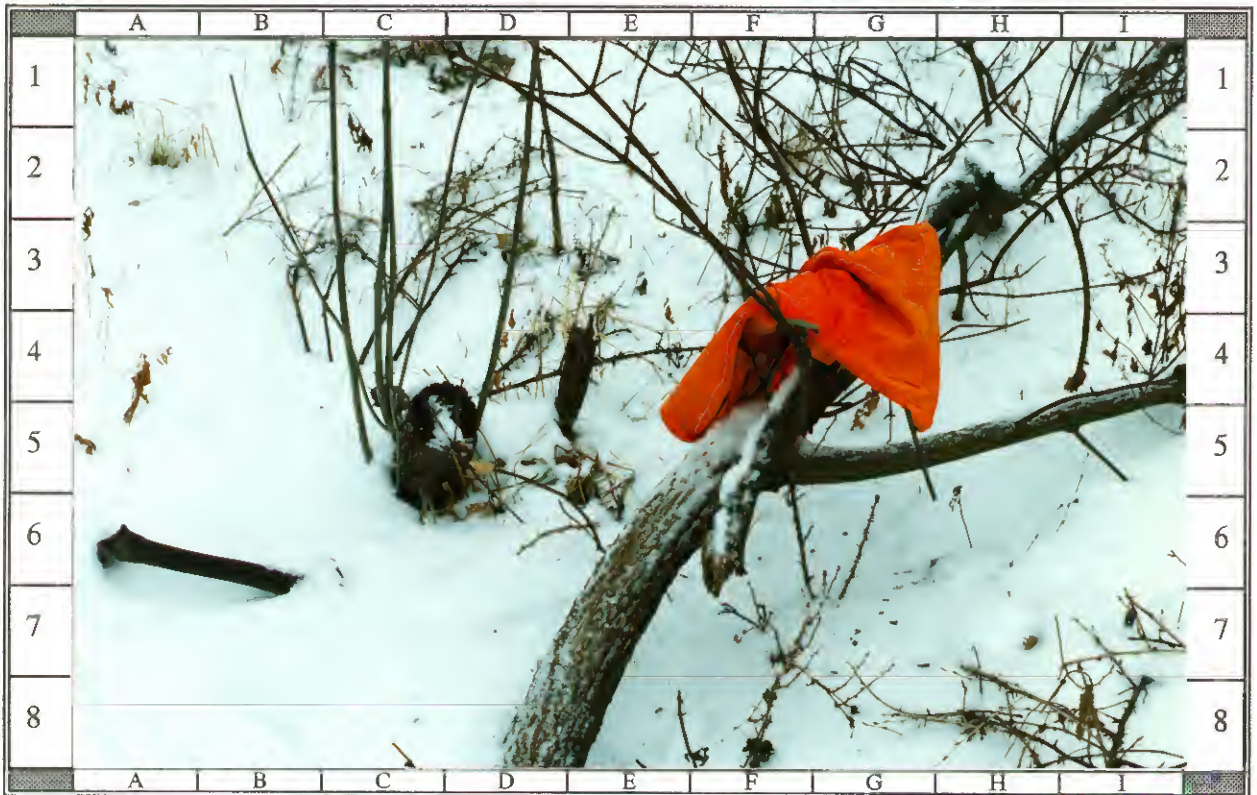
20 -- Closest-up of 1992 Ford Taurus's ~ final rest position at bottom of embankment heading east-southeast; NOTE: no contact to tree

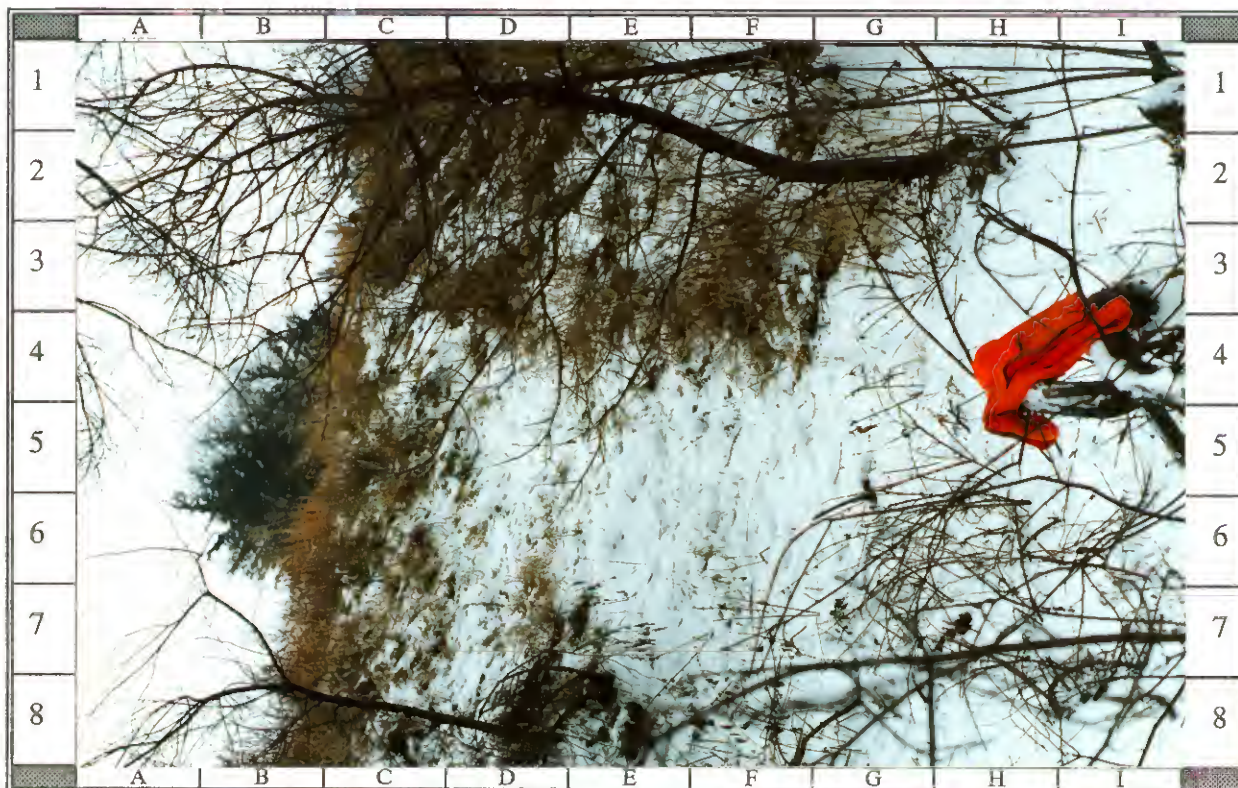
21 -- W-NW view from beyond ~FRP of '92 Ford Taurus's travel path; see tree & limbs (cells A7--D8) & bag deployment area (cells F5--G6)

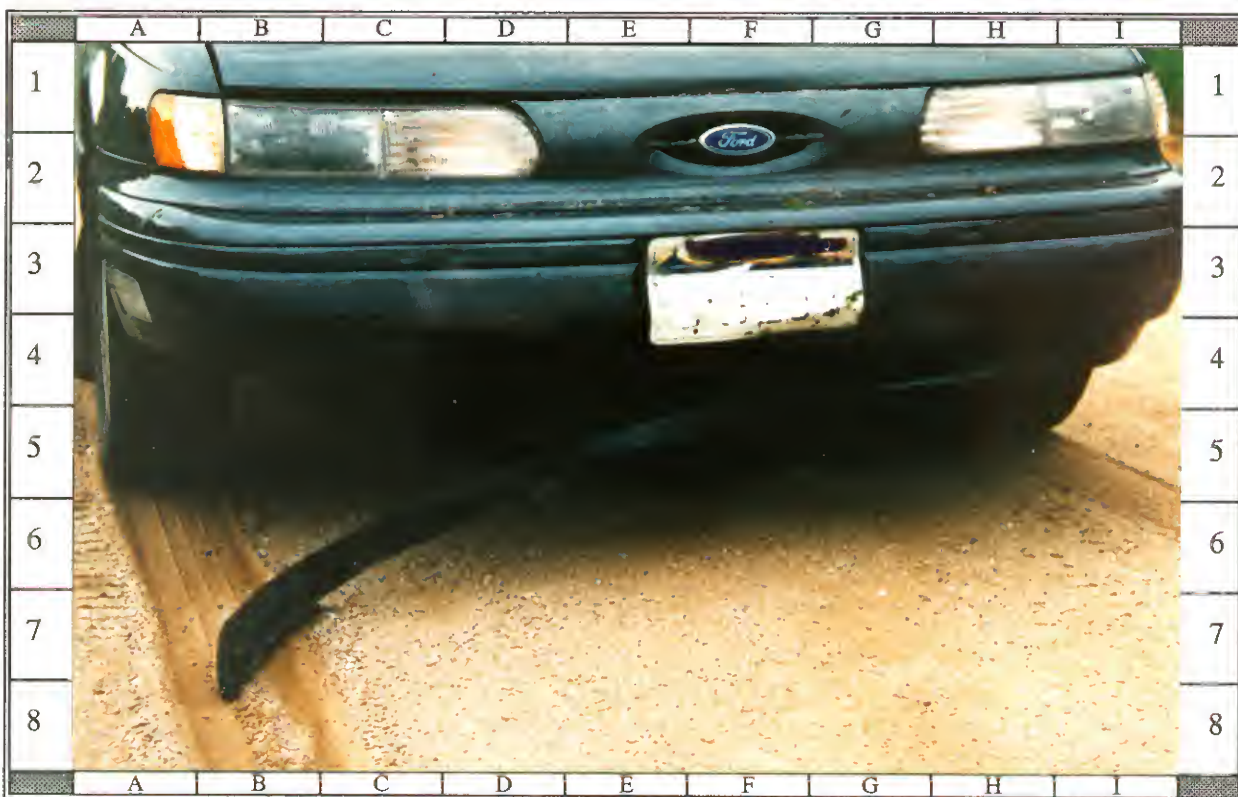
22 -- On scene close-up of 1992 Ford Taurus's damaged front bumper viewed from front--offset R; NOTE: soft sandy nature of roadway

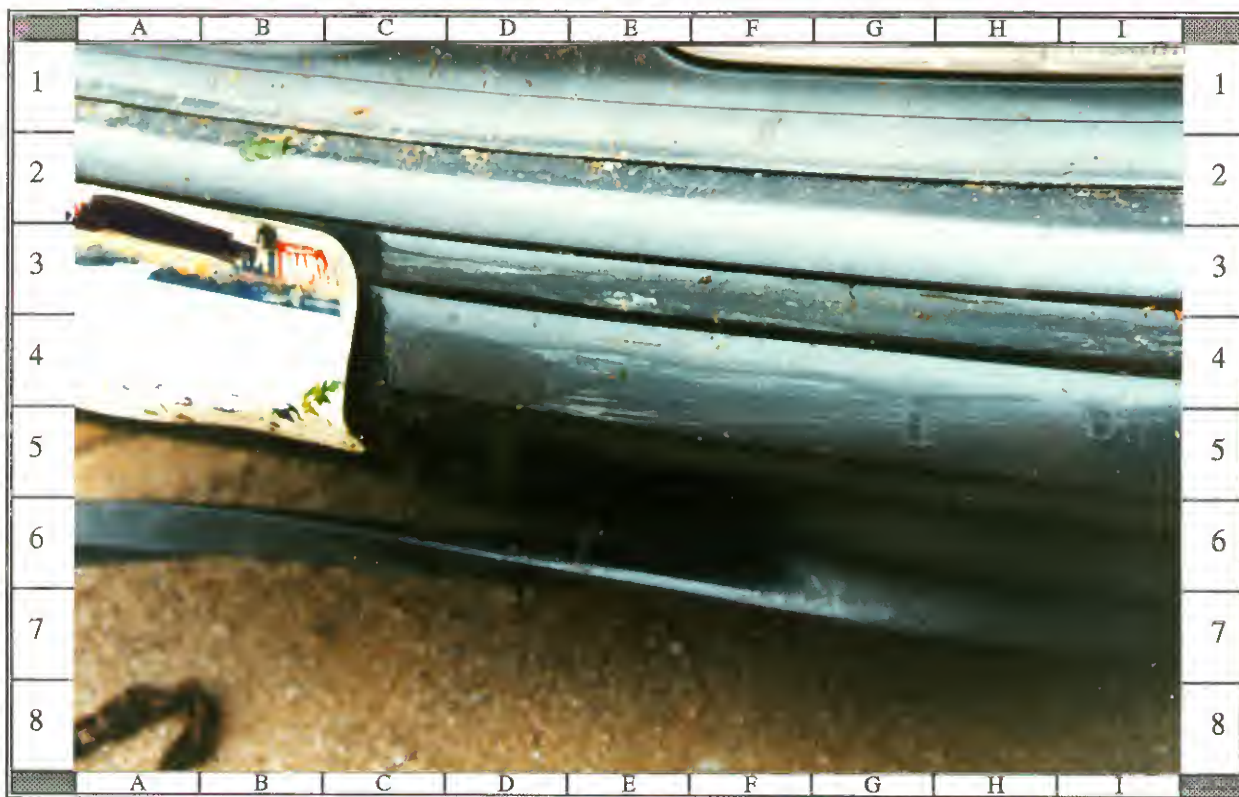
23 -- On scene closer-up of 1992 Ford Taurus's damaged front R bumper viewed from FR; NOTE: damaged air dam & grass above bumper

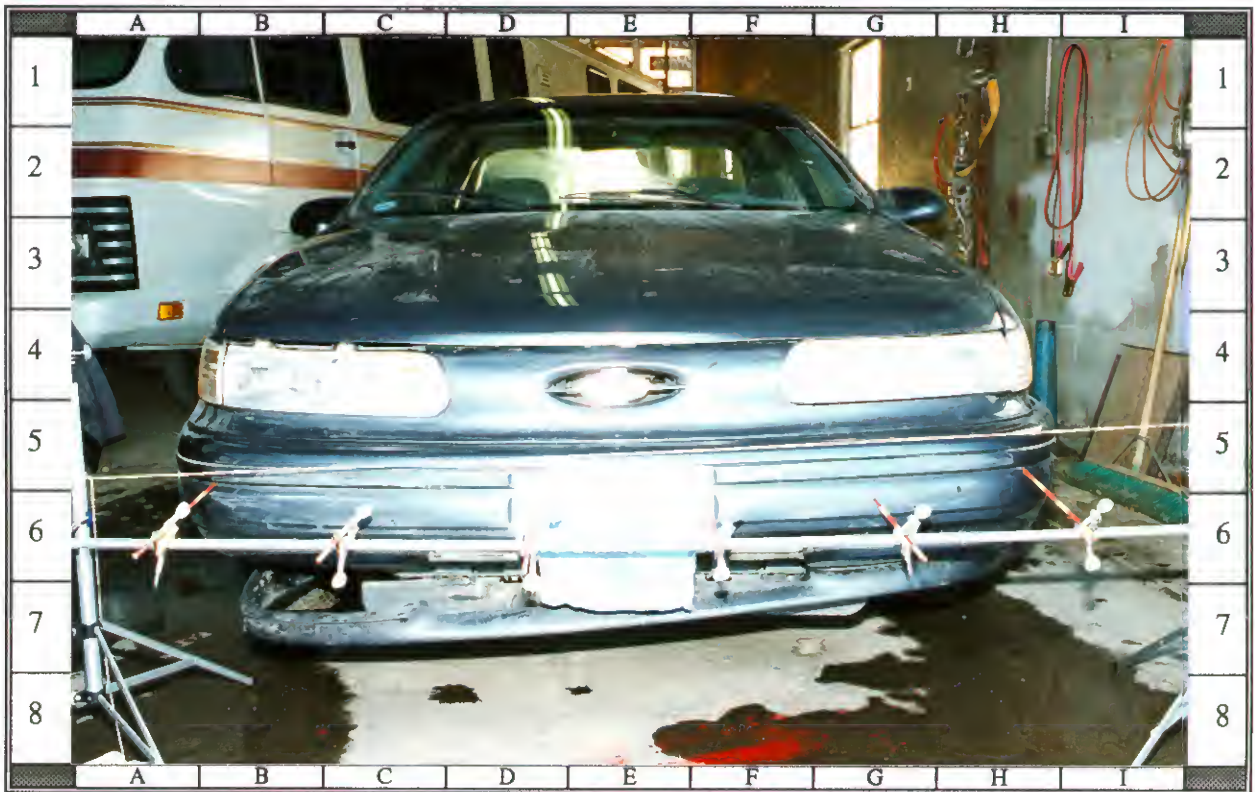
24 -- On scene closer-up of 1992 Ford Taurus's damaged front L bumper viewed from FL; NOTE: damaged air dam & grass above bumper
